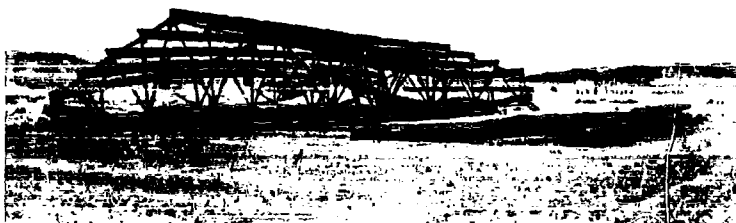
Figure 2.7 Posttest, TP 3.7 b-1 structure, front side view, facing northwest.

The TP 3.7b-1 structure collapsed in a direction away from ground zero (Figure 2.7). The end bents of the structure failed on the lee side by plastic buckling of the columns. All the truss-to-column connections on the ground zero side pulled away from the columns; the failure occurred in the truss-chord portion of the connection. In the interior bents the upper chord-to-column connections on the lee side failed by a combination of angle tearing and bolt failure. The lower chord-to-column connections on the lee side failed by buckling of the column flanges and tearing of the truss chord at the ends of the gusset plates. The lower chord-to-column connections on the ground zero side failed either in the connecting angle or in the bolts. The hinged column bases on the ground zero side appeared to be on the verge of failure. All these connections on the interior columns on the lee side failed because the anchor bolts for the restraining angles pulled out of the foundation. Both the end footings on the lee side of the structure were pulled out of the ground (Figure 2.8). There was pronounced bowing of the roof pur-

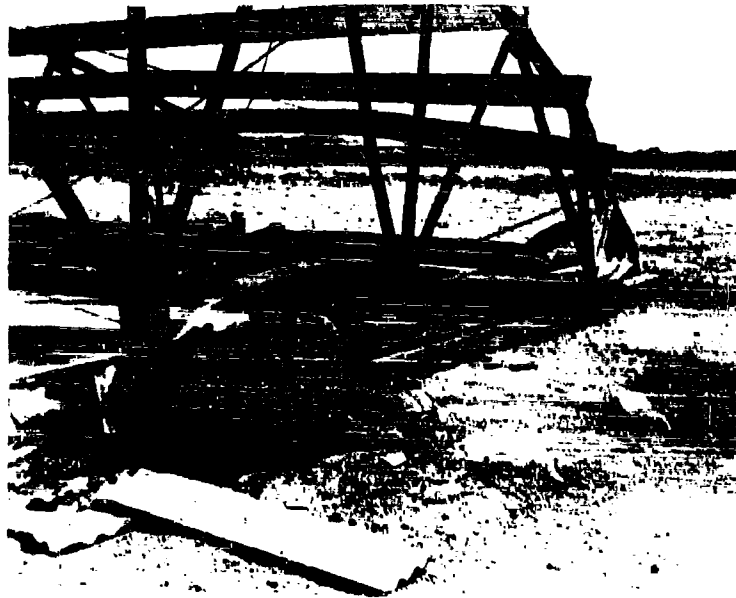
Figure 2.8 Posttest, TP 3.7 b-1 structure, view of north end column footing, facing southwest.

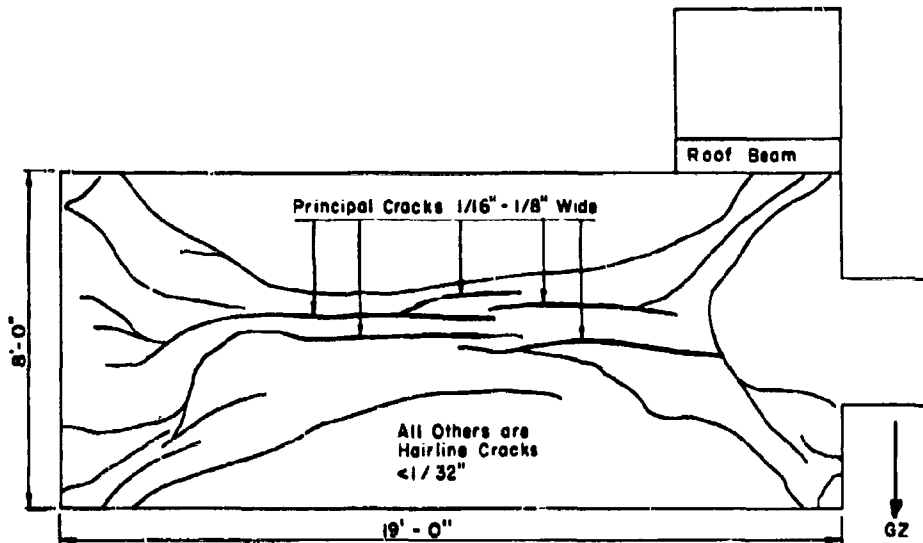
Figure 5.6 Crack pattern on roof of UK 3.7 structure.

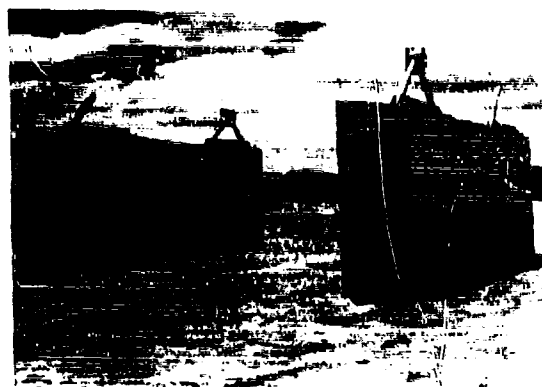
Figure 9.3 Posttest, UK 3.4b foundation, front side view, facing southwest.

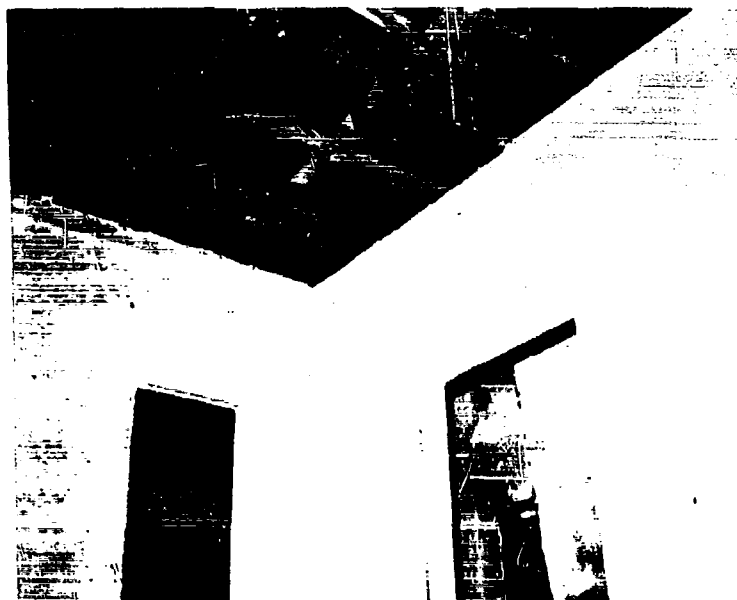
Figure 9.43 Posttest TP 31.1 a-2, second floor interior.

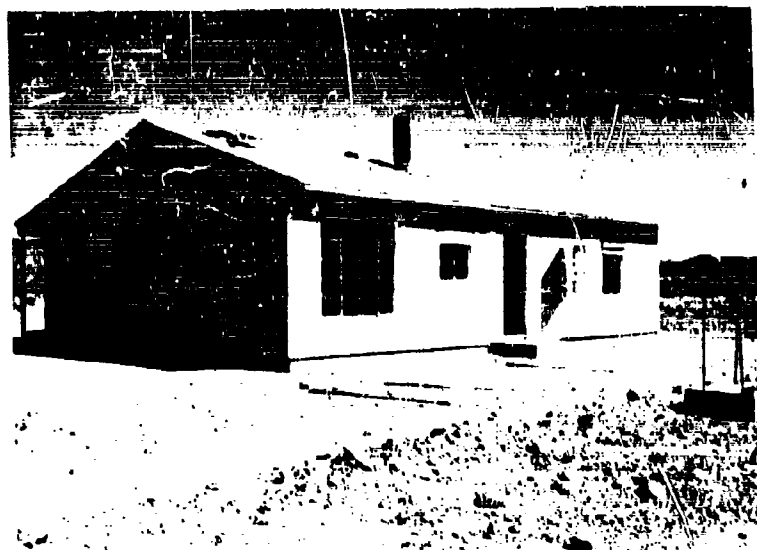
Figure 9.52 Posttest, TP 31.1 c-2, side view of building.
facing northeast.

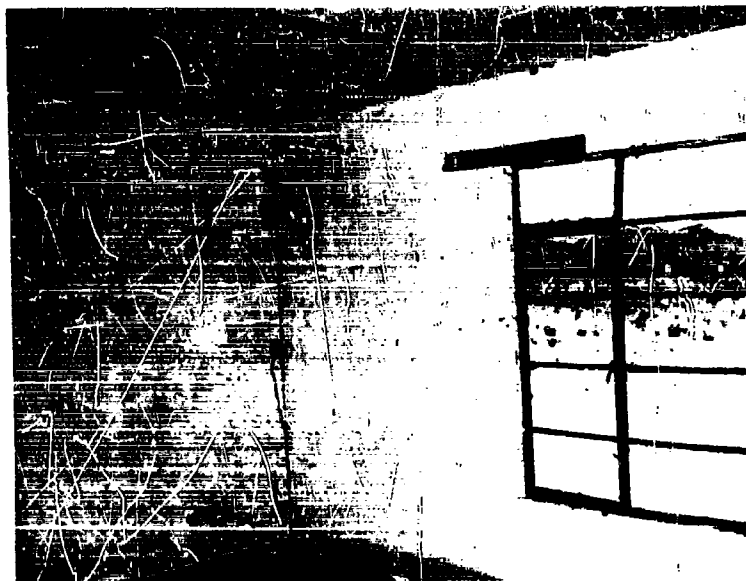
Figure 9.57 Posttest, TP 31.1 e-1, interior of living room, facing northwest.
